IBM PCB Symposium

Lead-Free Laminate Robustness

Brett Krull, Dept FM2

Nov 18, 2009

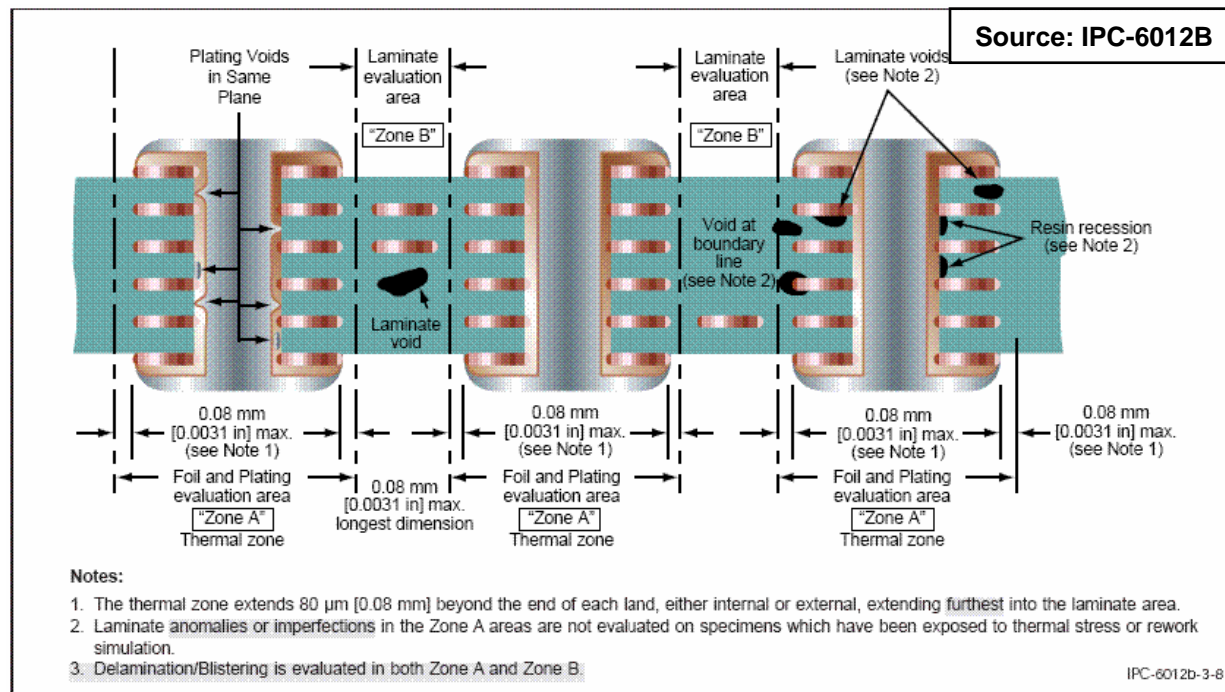
Figure 3-8 Typical Microsection Evaluation Specimen (Three Plated-Through Holes)

- Crack requirements described by IBM Specification 53P4082 (section 3.6.2.3 - 3.6.2.5), referencing IPC-6012B (section 3.6.2.4)
 - Thermal zone redefined extending to within .004” of PTH land
 - Minimum continuous dielectric between uncommon conductors : .004”
 - Per IBM 53P4082 (section 3.6.2.5) delamination and blisters not allowed

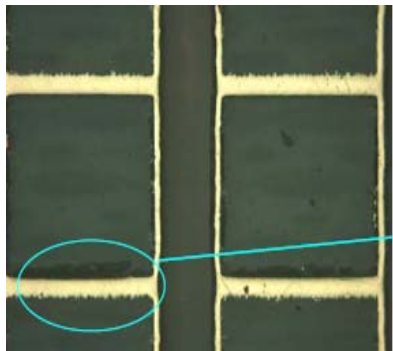
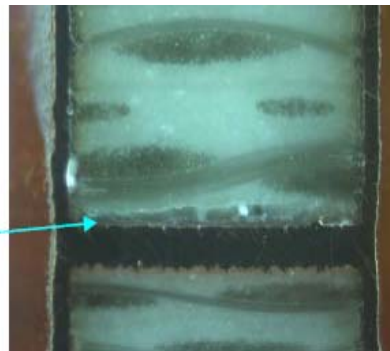
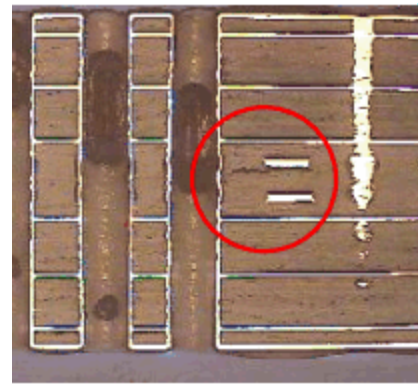
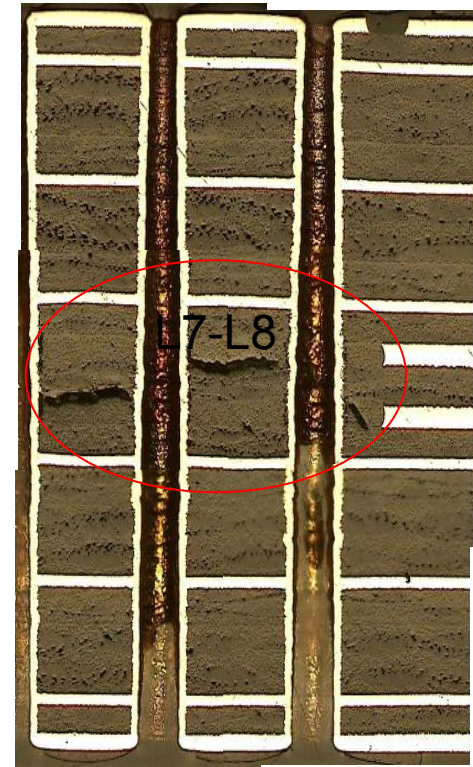
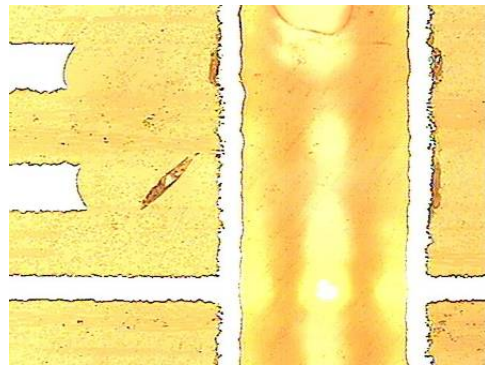
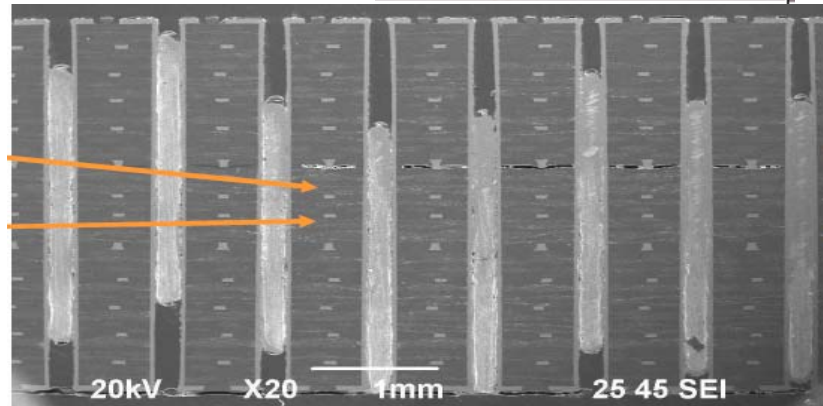
- Reliability impacted by crack size, location, and frequency
 - Increased chances to form internal shorts
 - Mask other defects during qualification (ATC stress relaxation)

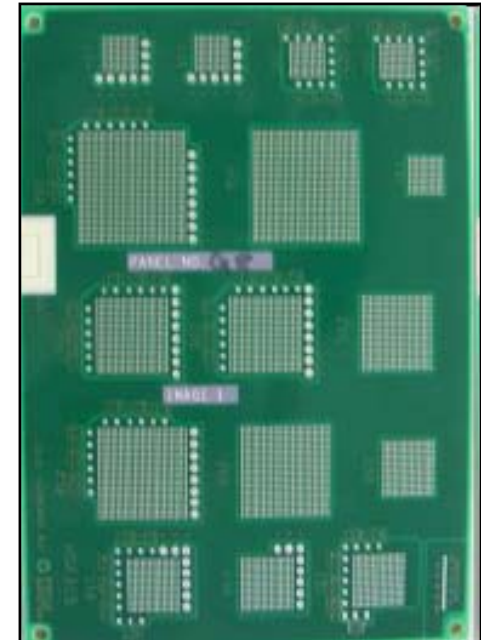
- **Laminate Integrity Test**
 - Simulated reflow conditioning for all coupons
 - Localized cross-sections of product cards (and assemblies when available)
- **Specialized HOP31B Coupon (IBM PN 42R8302)**
 - Square arrays of 8-mil vias at .8mm pitch (10-30 via square arrays)
 - Include “pipe bomb” enclosed laminate configuration
 - Capacitance and impedance used to track moisture migration
- **Continuation of Legacy Reliability Tests**
 - Accelerated Thermal Cycling (ATC)
 - Insulation Resistance (IR)
 - Extended product monitoring

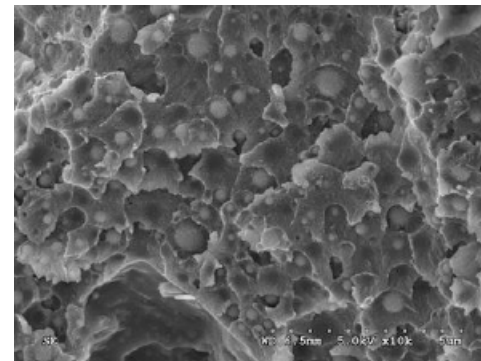
- Mechanical testing performed by Dr. Ray Pearson, Lehigh University
 - Fracture Toughness testing – ASTM D5045, SEN-3PB (single-edge notched 3-pt bend)
 - Quantitative Fracture Toughness data - Critical Energy Release Rate (G_{IC})
 - Interfacial and interlaminar fracture toughness test development
 - Fracture/failure surface examination (SEM/EDS)
- Unanswered questions will drive the next phase of the project
 - Are reflow performance and fracture toughness related?
 - What actually breaks in a laminate failure? Where is the weak point?
 - How do coupling agents affect laminate performance and failure mode?

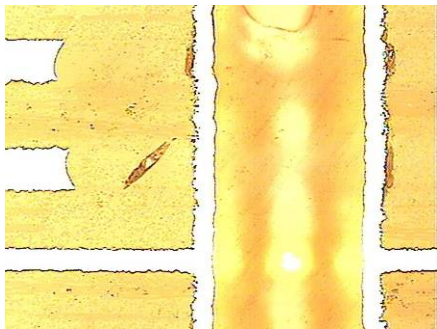
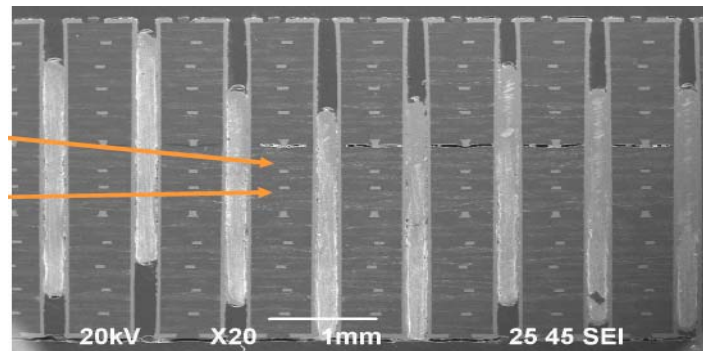
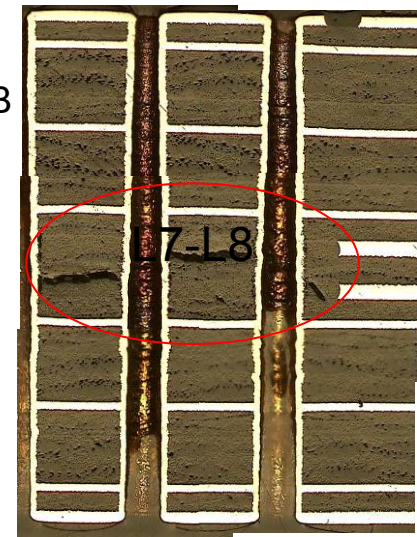
- PCBs must survive assembly conditions:
 - Laminate integrity requirements
 - Laminate materials must endure thermal stresses from soldering processes
 - Conventional Sn-Pb solders: ~220°C
 - Mixed Solder Assembly: ~245°C
 - Full Lead-Free Assembly: ~260°C
 - Test methods
 - Most qualification test vehicles undergo simulated assembly in a reflow oven
 - Specialized coupon tests “worst-case” laminate integrity design points
 - Failure Modes
 - Material limits, poor fabrication, or excessive moisture may weaken PCB
 - Still very much in the learning phase with respect to laminate strength

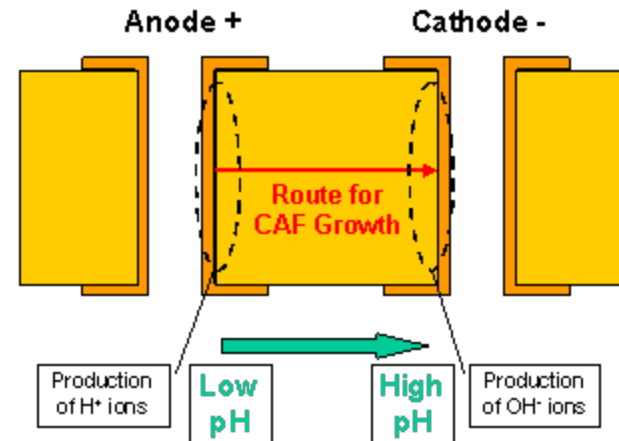
- Internal shorts of the PCB may result from an electrochemical reaction driven by a voltage gradient
- Insulation Resistance measures PCB susceptibility to growing a short

- Moisture → Unavoidable in manufacturing or the field
- Voltage Gradient → Present on all PCB designs
- Pathway → **Preventable** if proper precautions taken

- Tight via-via pitch
- Material limitations
- Hollow glass fibers
- Laminate damage
- Process defects/limitations

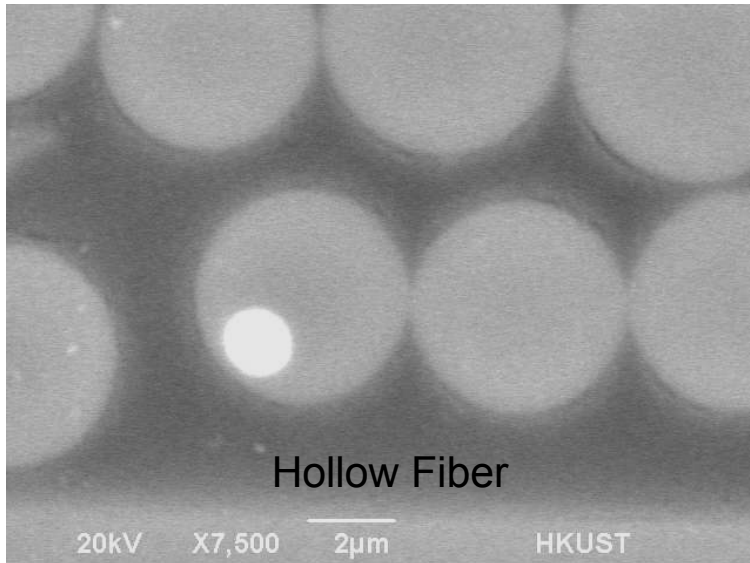
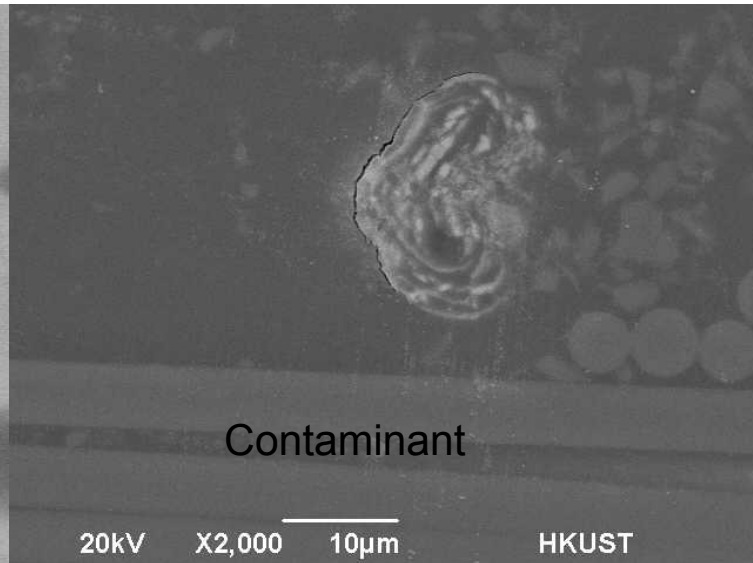
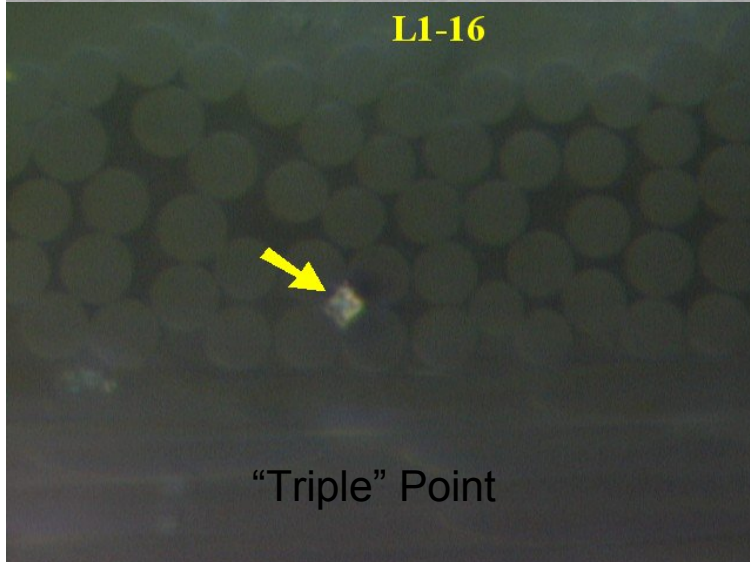
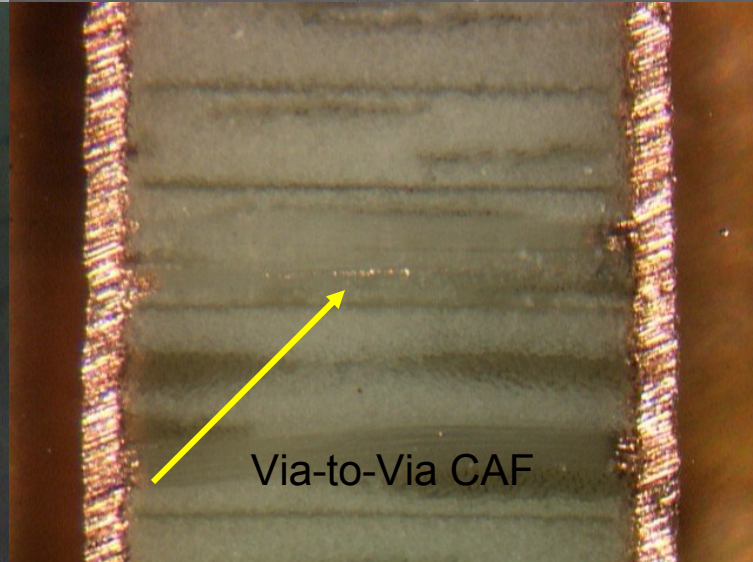
IR Continued

- Test conditions and requirements
 - Simulated assembly and ship shock performed on new parts
 - Parts tested in T&H chambers 50°C / 80% RH
 - 15V bias applied (~3x relevant application voltage)
 - 1 Megohm current limiting resistor protects fragile CAF filament (100 μ A max)
 - Resistance measured intermittently. Failure condition is $R < 100$ Megohms
 - Requirements drawn from experimentally determined acceleration models
 - I, P, X Series and Storage Servers: 300 Hours
 - Z Series : 600 Hours
- Common failure modes
 - Via-to-Via → Resin/glass separation, hollow glass fibers, poor resin fill
 - Via-to-Plane → Contaminants during lamination, laminate damage
 - Plane-to-Plane → Resin gaps in single ply materials, laminate damage
