IXA Installation Problem Determination Guide

Version 1.0

To be used in addition to the Integrated xSeries® Adapter (IXA) instructions located on the following web page:

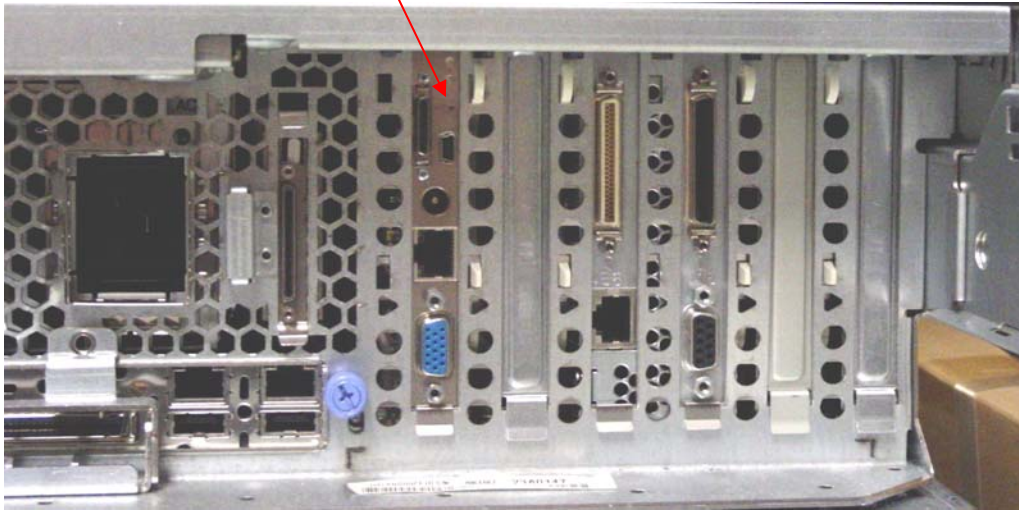
Picture #1: RSA II reset switch

<p>7) Disable your PC firewall software till after the update is completed. WARNING: RSA II cards <u>CANNOT</u> be flashed / updated using the Update Express CD , the CD will tell you it has worked , will show you the new BIOS level , but will never talk to the IXA correctly , giving you no IOA or associated adapters below it reporting in on the WRKHDWRSC *CMN command.</p>
RSA II firmware won't install.	1) Wrong download?	<p>1) RSA II cards use packet files for the firmware updates. The files are named *****US.PKT. Recheck the download being used, check IXA installation documentation for what to use. Retry with the new files.</p> <p>NOTE: you must use a laptop connected with either a cross-over cable or through a switch to the ethernet port on the RSA II card. Do not use the update express CD to do this.</p>
Server won't power on or reboot.	RSA II User ID and password have been changed?	<p>1) Use a paperclip and reset the RSA II defaults using the hole in the tailstock of the RSA II. See picture #1 at the end of the document. NOTE: RSA II SlimLine doesn't have this reset button</p> <p>2) Use the RSA II GUI (requires knowledge of the user ID and password and reset them to USERID and PASSWORD (Zero, not O).</p>

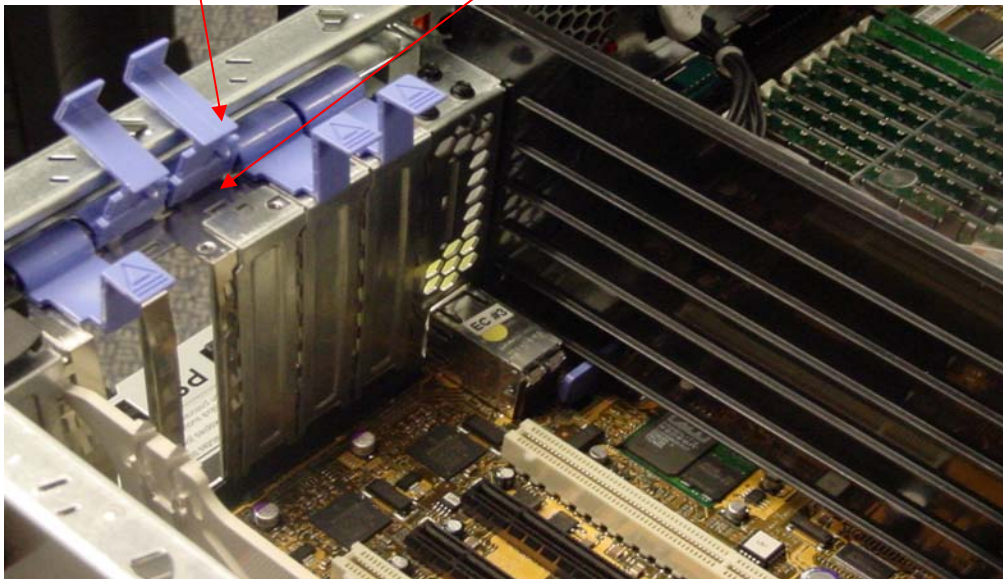
Picture #2: Stub on xSeries® latch and hole on xSeries® for tailstock flange.

Symptom(s)	Possible Cause(s)	Recovery
IXA card won't fit into the defined slot.	<ol style="list-style-type: none"> 1) Is the blue card extender handle removed? 2) Black and orange slot switches opened? 3) Proper model IXA for the server being installed? 4) Latches on the xSeries® slots for the IXA making good contact? 	<ol style="list-style-type: none"> 1) Check the IXA installation document, the blue card extender handle may need to be removed with a T10 Torque wrench (included in IXA kit). 2) Open the black and orange slot switches to allow card to be inserted. 3) Use the proper model IXA for the server being installed (see web page link on the title page of this document). See the web page for details. See pictures #4 & 5 at end of document. The wrong IXA card won't fit in the slots of non-supported servers. 4) Check latches on the xSeries® slots for the IXA, latches must be down flat for good switch contact. Flange on IXA tailstock may not be inserted in the hole in xSeries® frame. See pictures # 2 & 3 at the end of the document.

6) IXA plugged into slot 5 on xSeries® 235 (For models 11X, 1AX, 21X, 2AX, 31X, 3AX, 41X, 4AX and 6AX, use card position 4.)?	on back of server frame. See pictures #2 & 3 at end of the document. 6) Some x235 motherboards have problems supplying standby power to IXA cards, move the IXA to slot 4 and try it there - no jumpers are required to use slot 4.
--	---	--

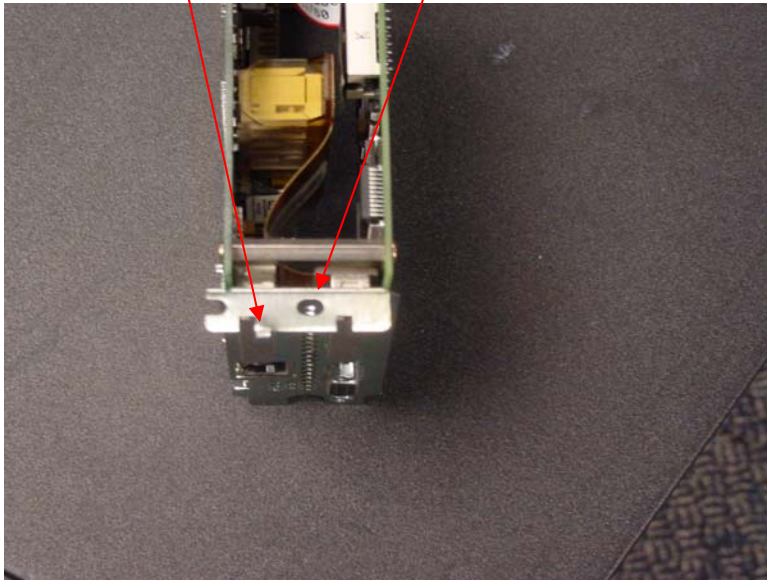
Picture #3: Tailstock flange and hole in tailstock of IXA (for stub on xSeries® latch)

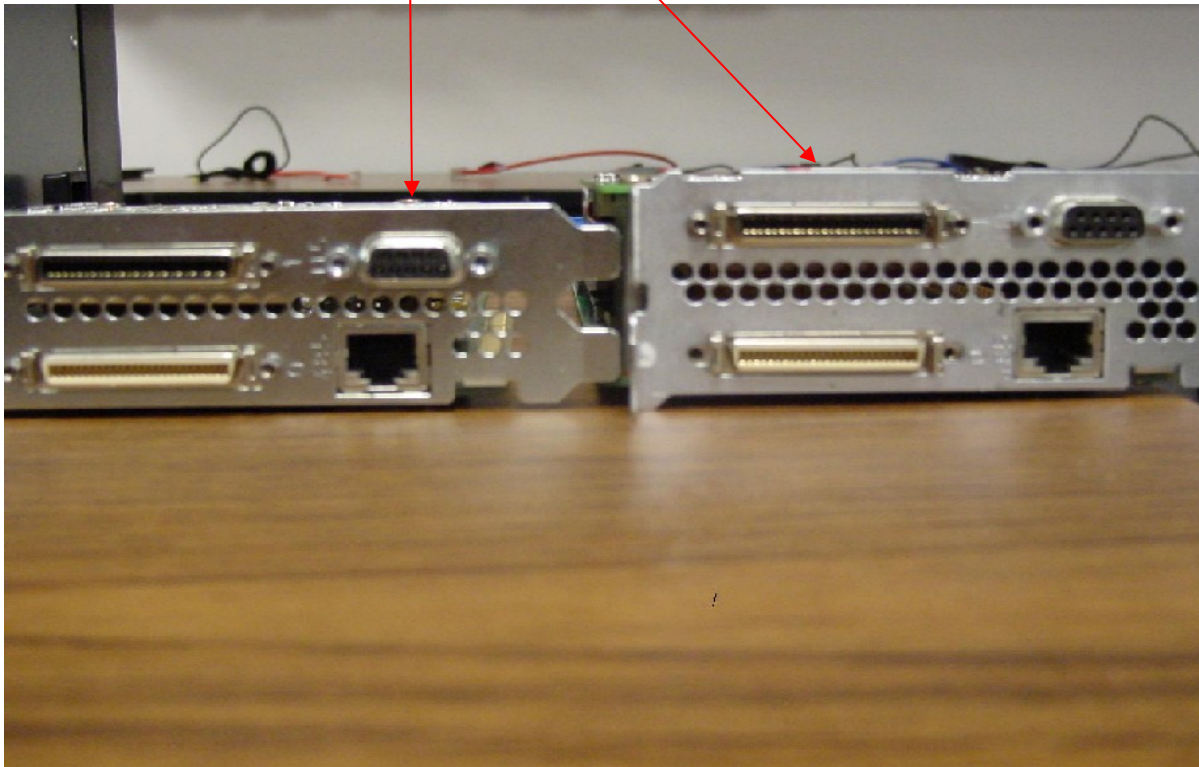
Picture #4 IXA comparison: 1519-200 versus 1519-100 (note the thickness of the cards)

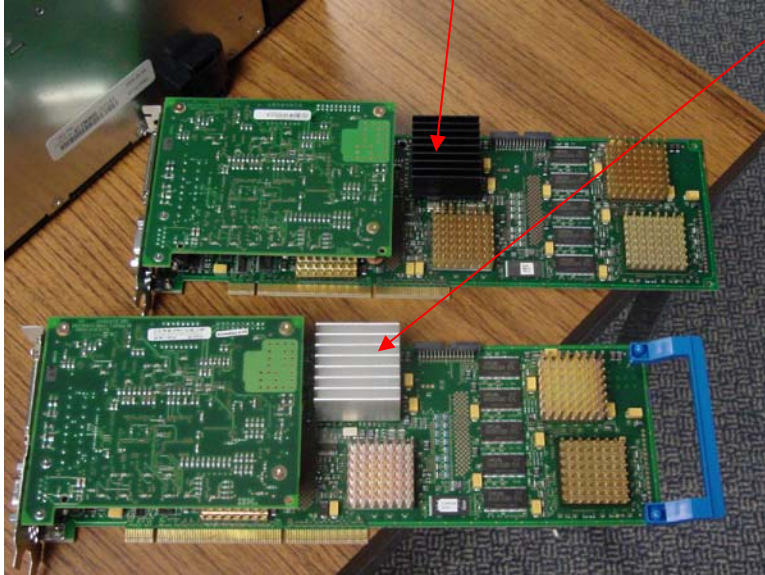
Picture #5 IXA comparison: 1519-200 (handle missing) versus 1519-100 (side view). Note that the color of the heat sinks are different.
